PostParc Berne
Berne railway station development project

Expansion joints
Evaluation of pilot project with *Polyflex Advanced* system

Berne, 26.08.2014

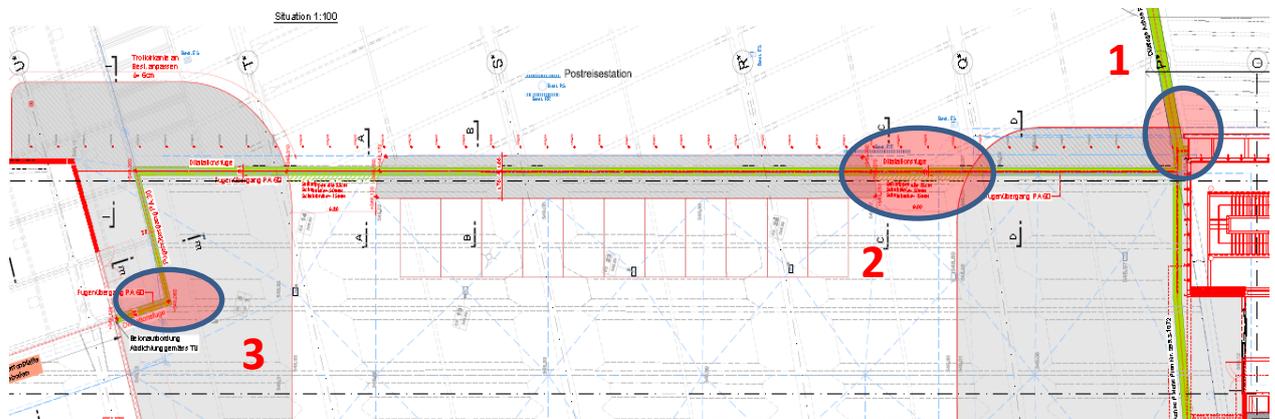
The three test strips were situated at the building site's perimeter, at locations with varying demands on the expansion joints and where the construction work would not be hindered:

Joint 1: The largest longitudinal movements, no traffic loading, step

Joint 2: Small longitudinal and transverse movements, heavy traffic loading (construction site traffic at site entrance)

Joint 3: Corner point with movements in two directions, no traffic loading

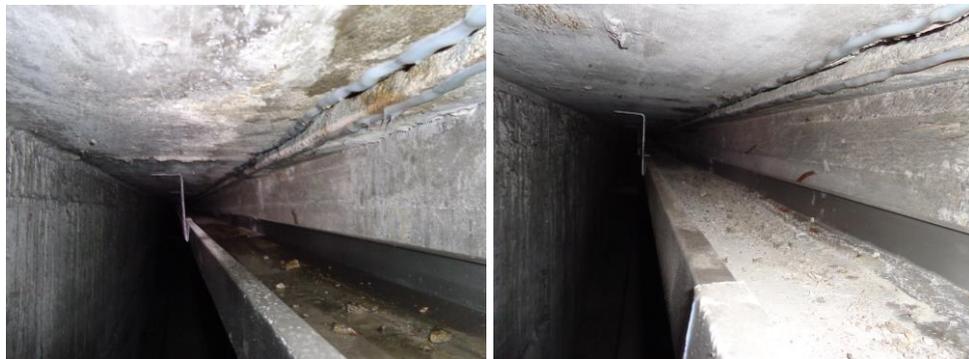
Test Strip 2: Underside could only be viewed with difficulty due to temporary metal gutters. The gutter in the south connection area was wet, directly beneath the new expansion joint it was dry. It may be assumed that the expansion joint is watertight and that the observed water got in from the south side.

Water in the metal gutter

Gutter dry beneath the new expansion joint

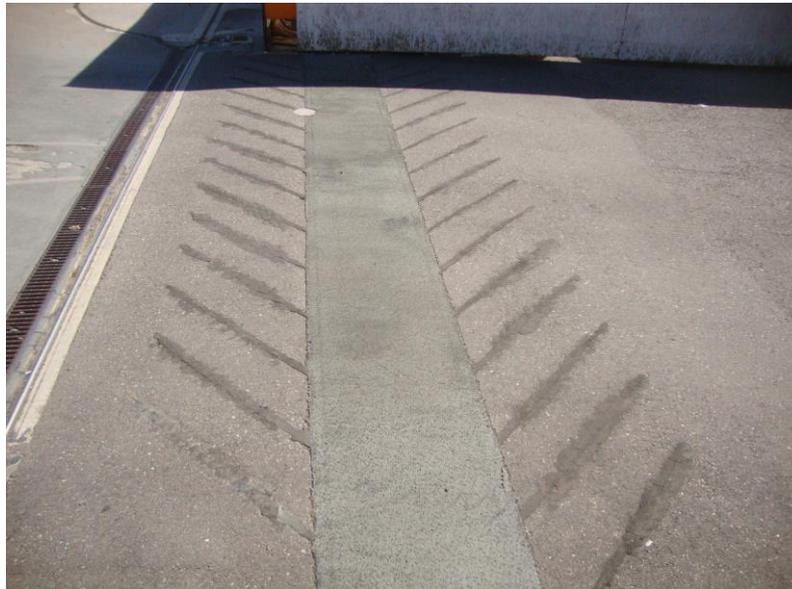
Test Strip 2, at the entrance to the PostParc construction site, was exposed to heavy construction traffic during the entire duration of the test programme. Due to this expansion joint's location directly at the site entrance checkpoint, the wheels of trucks will have stood directly on the expansion joint, for extended periods, many times during the testing period. After a year of intense loading, the expansion joint showed nothing more than colour changes. Neither rutting nor plastic deformations, of the type known from other systems, could be seen.

No rutting or plastic deformation could be seen

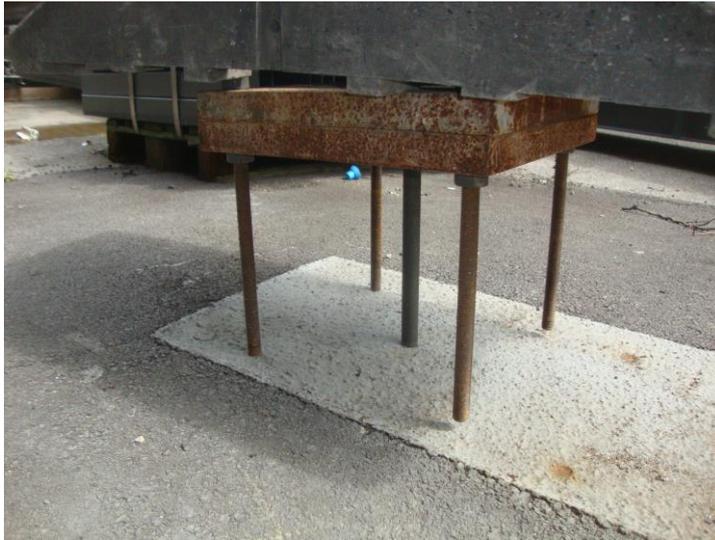
A) Duration 4 weeks, temperature max. 28°C, Loaded surface area 3.1 cm², Load 700 N (70 kg).

The penetration bar pushed approx. 20 mm into the joint's material, until all its support points were resting on the surface, at which point the test frame did not sink in any further.

Penetration test with an iron bar of diameter 20 mm and a load of 70 kg

The point loading resulted in the loaded bar pressing into the joint's material. Under this form of loading, the material behaved elasto-plastically, with the impression left by the loaded bar disappearing within a day. The expansion joint did not lose its watertightness. The applied load of 70 kg (0.7 kN) resulted in a pressure of 2.25 N/mm² on the expansion joint.

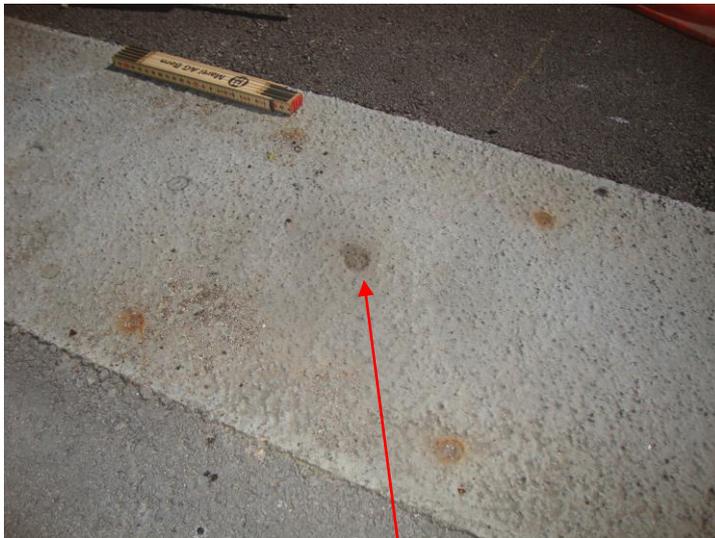
The impression made by the iron bar
has flattened out again

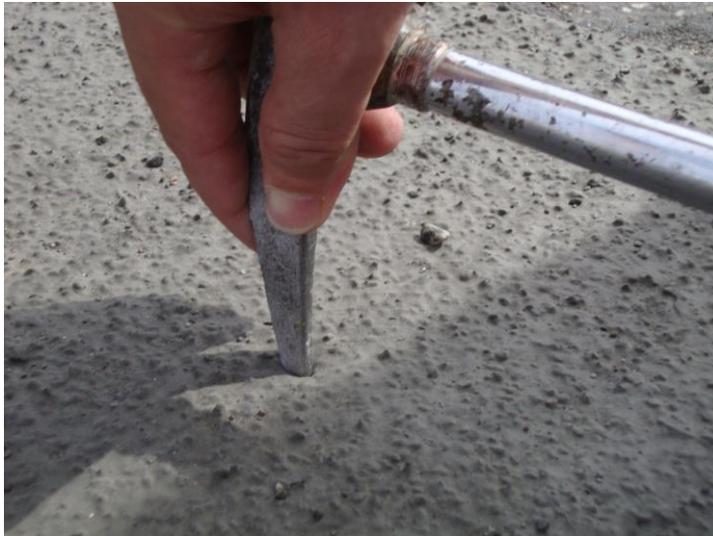
C) Duration: Several seconds, temperature 20°C, pointed object (scabbling pick)
Only a small penetration. No lasting damage to the joint's material.

Penetration test with scabbling pick C)

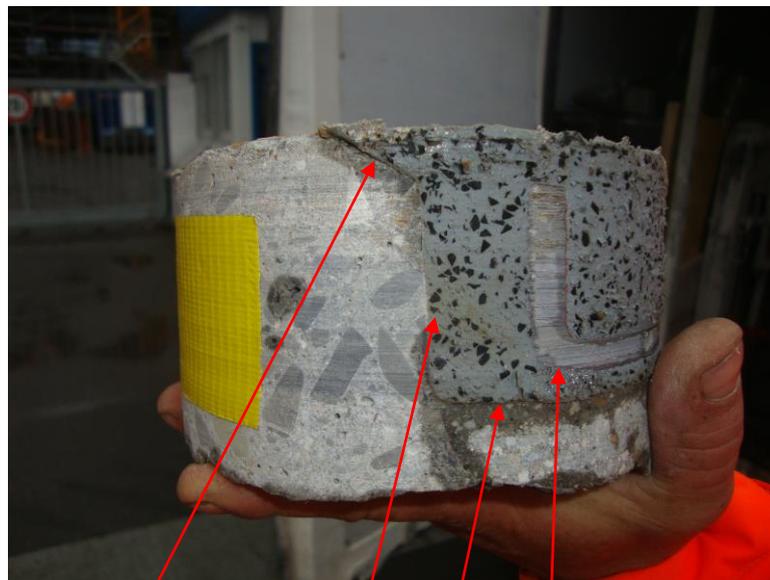
In the area of the chamfer (approx. the upper 8 mm), the joint material detached itself from the concrete. According to the manufacturer, this chamfering is part of the expansion joint system and is provided in order to prevent this apparently inevitable detachment from extending down into the area with vertical surfaces. Presumably, additional maintenance work such as cutting and re-pouring is required in this area.

Detachment in area of
chamfering

No detachments

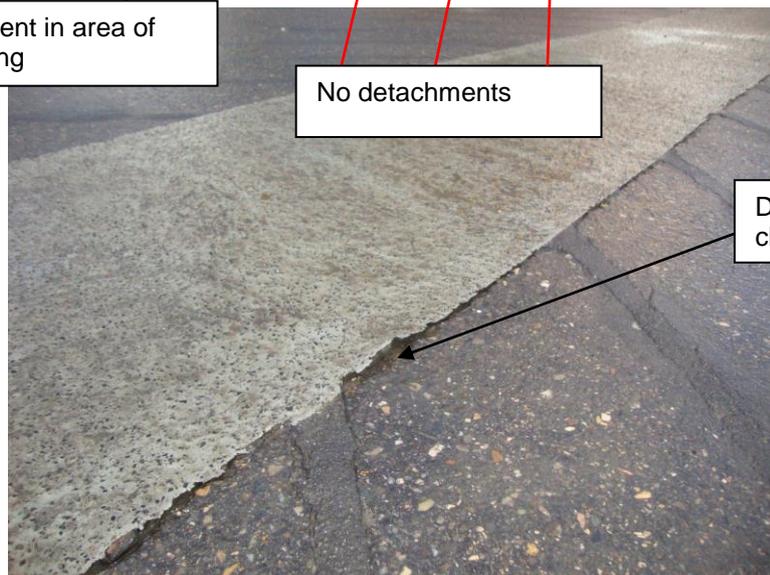
Laboratory examination

Laboratory examinations (thin section analyses) by the company Geotest AG showed, for Test Strip 1, good adhesion to the concrete. The joint material could not be tested in a tensile test to its limits, because the testing equipment had a limited testing range. The laboratory testing thus verified the very high stretchability of the material.

Specimen 2 had no adhesion or only poor adhesion between the joint material and the asphalt surfacing. The removal of the cored specimen in the asphalted surfacing was difficult. We assume that the specimen became unusable as a result of mechanical damage during core removal.

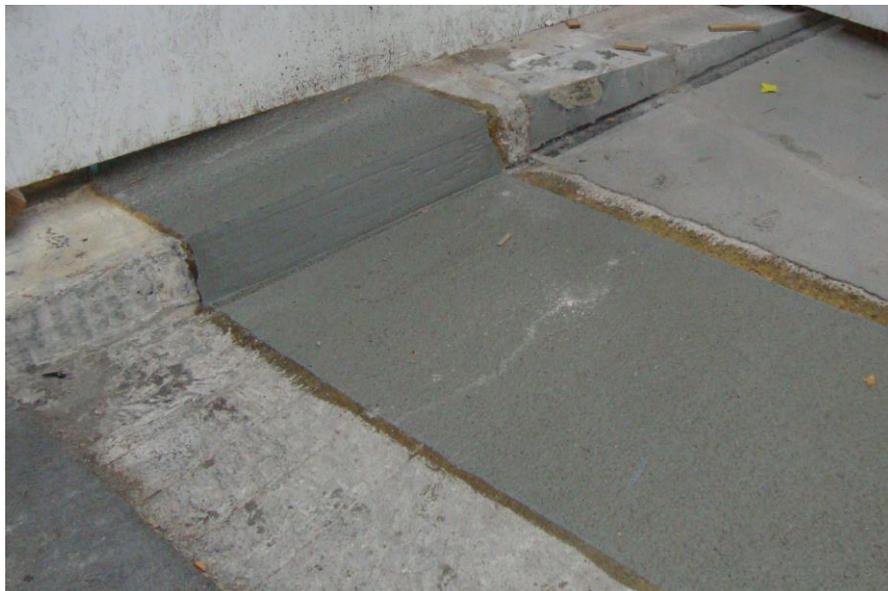
The *Polyflex Advanced* system was selected in the early part of the year for the test strips at the PostParc because it was the only new-type system available on the market and already had testing certifications. The installation went smoothly, without any problems, including even the formation of the step at the postal car ramp.
